# WHITTINGTON TOWNHOME ASSOCIATION

## WATER SERVICE LINE REPLACEMENT GUIDE

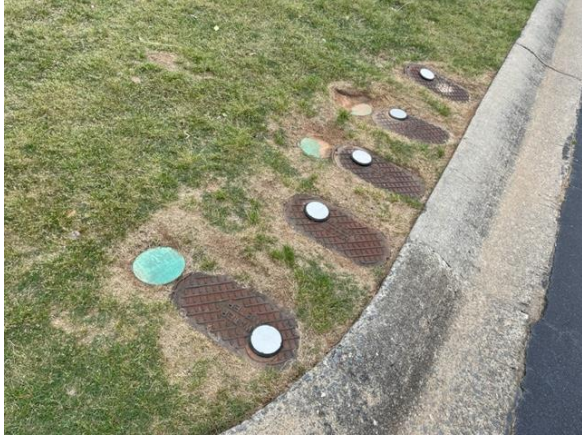
White PVC cleanout

From there, the Blue Poly lines transition to copper lines at the Sanitary Sewer Cleanout which is located within five feet of the front of each townhome. The Sanitary Sewer Cleanout is White - 4" PVC with a removable cap.

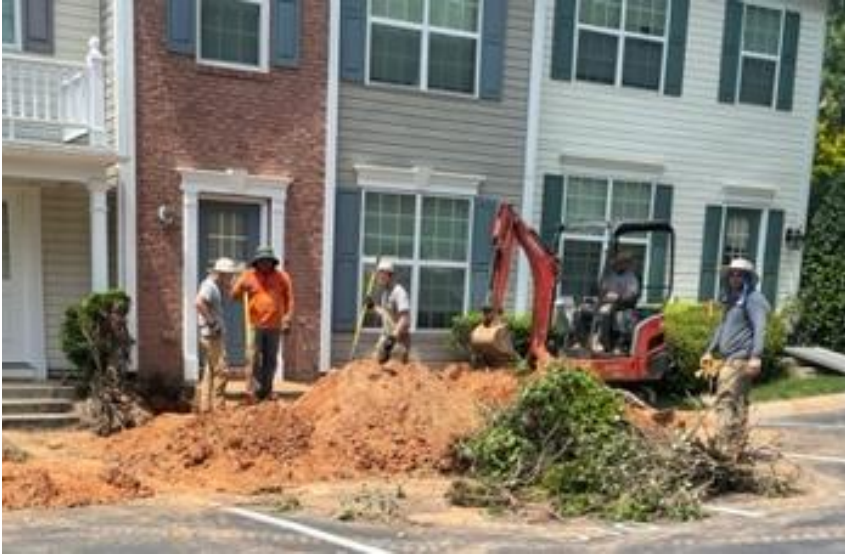
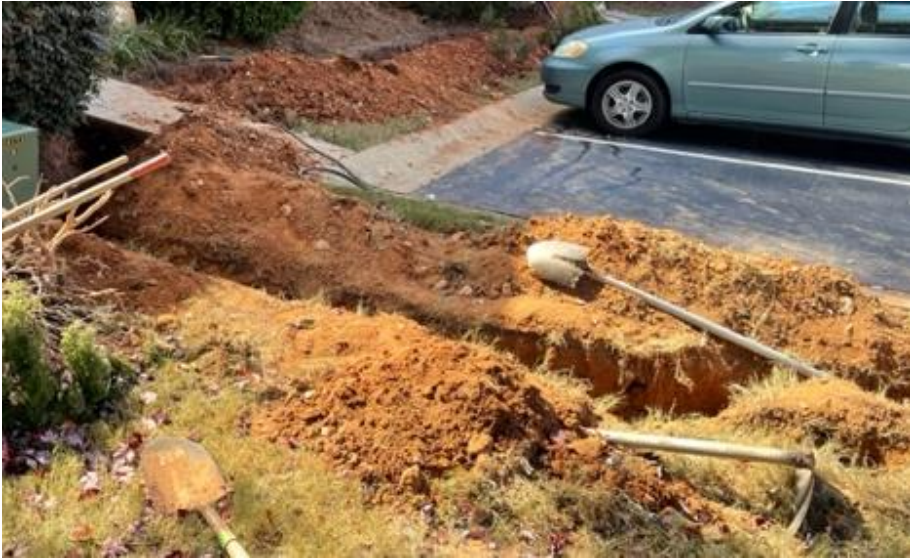
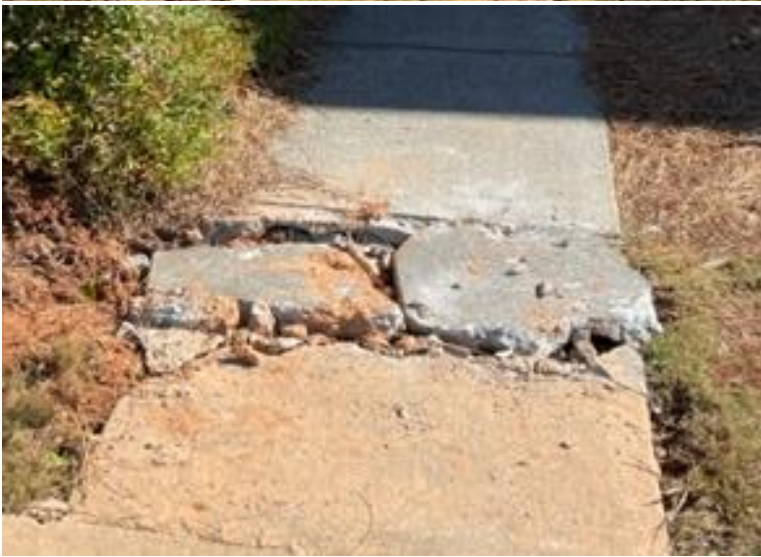
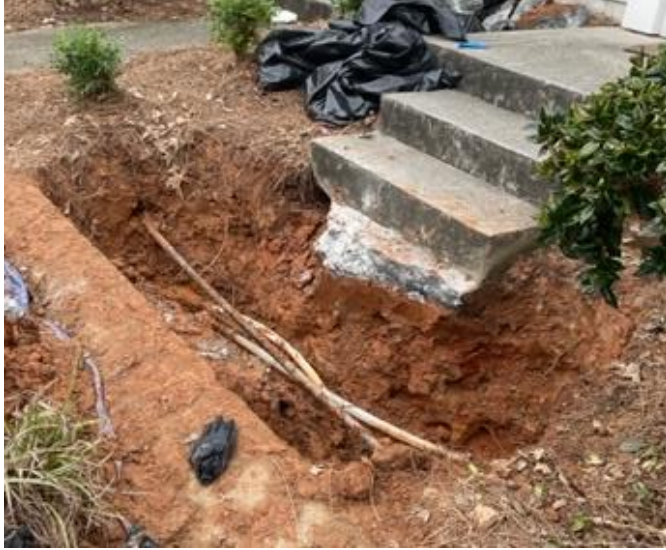
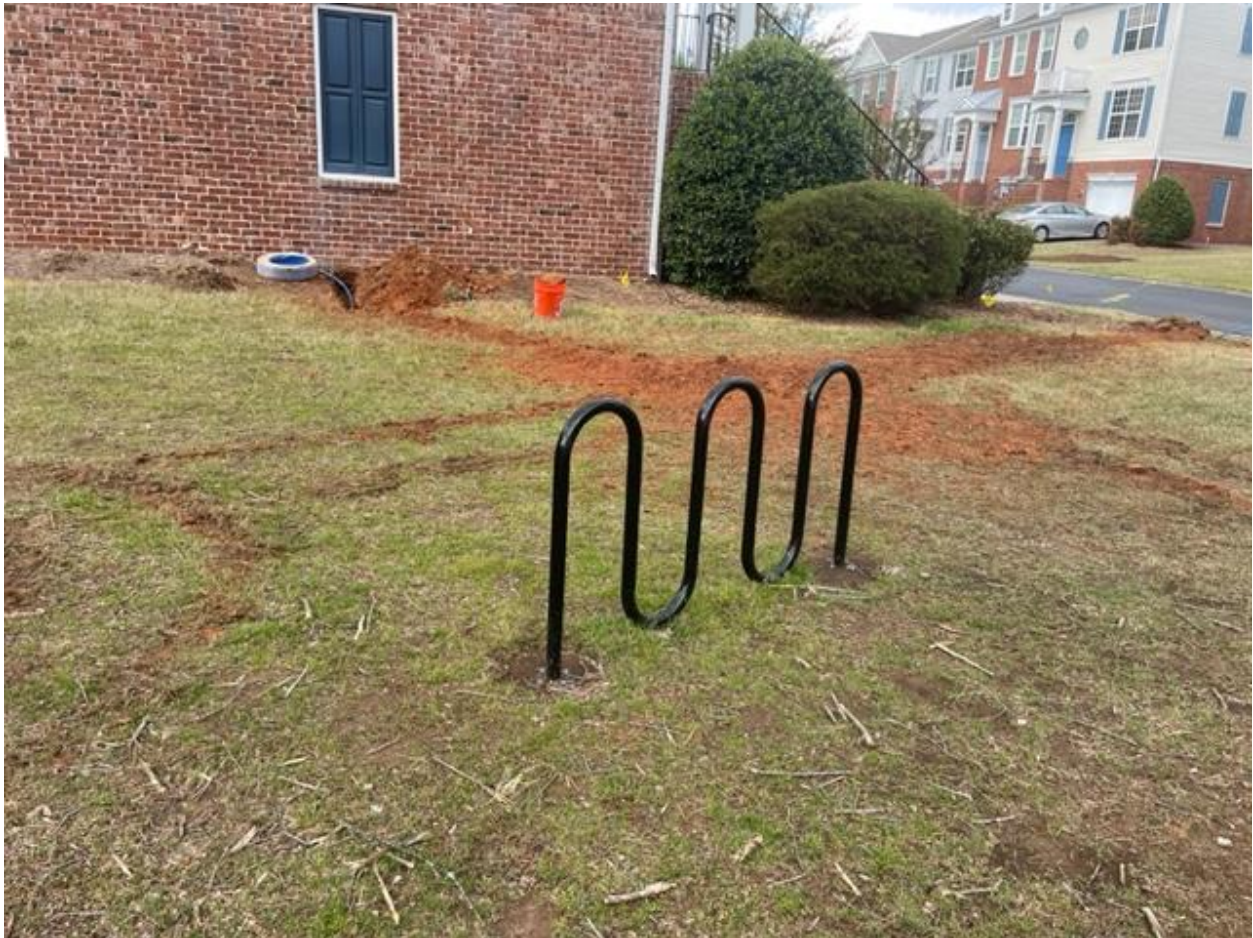
The following are photos of improperly done water service line replacement at Whittington:

***Improper Proper Repair Procedures*** – Unfortunately, too many plumbers are not knowledgeable enough to effectively fix the leaks as described. There have been many, too many, homeowners that have paid for repairs only to have the same plumber return to fix the same line again. Some homeowners have even had to pay another plumber a third time before the problem is solved. If your plumber tells you any of the following, we recommend finding another plumber:

- (1) “We can replace a section of the water line by digging up the leaking section”.
- (2) “The leak is under the concrete slab”.
- (3) “The driveway or sidewalk must be cut and repaired”.
- (4) “We will install a new water line around the side of the building to the rear storage closet or to the side of the garage”.
- (5) “They show up with a trenching machine”.
- (6) “We need to remove all of your shrubs.”
